# DEPARTMENT OF HOMELAND SECURITY

Customs and Border Protection

## Other Incident Investigation Investigation Report

Investigation into the line of duty death of SPA Luis A. Aguilar (YUM/YUS)

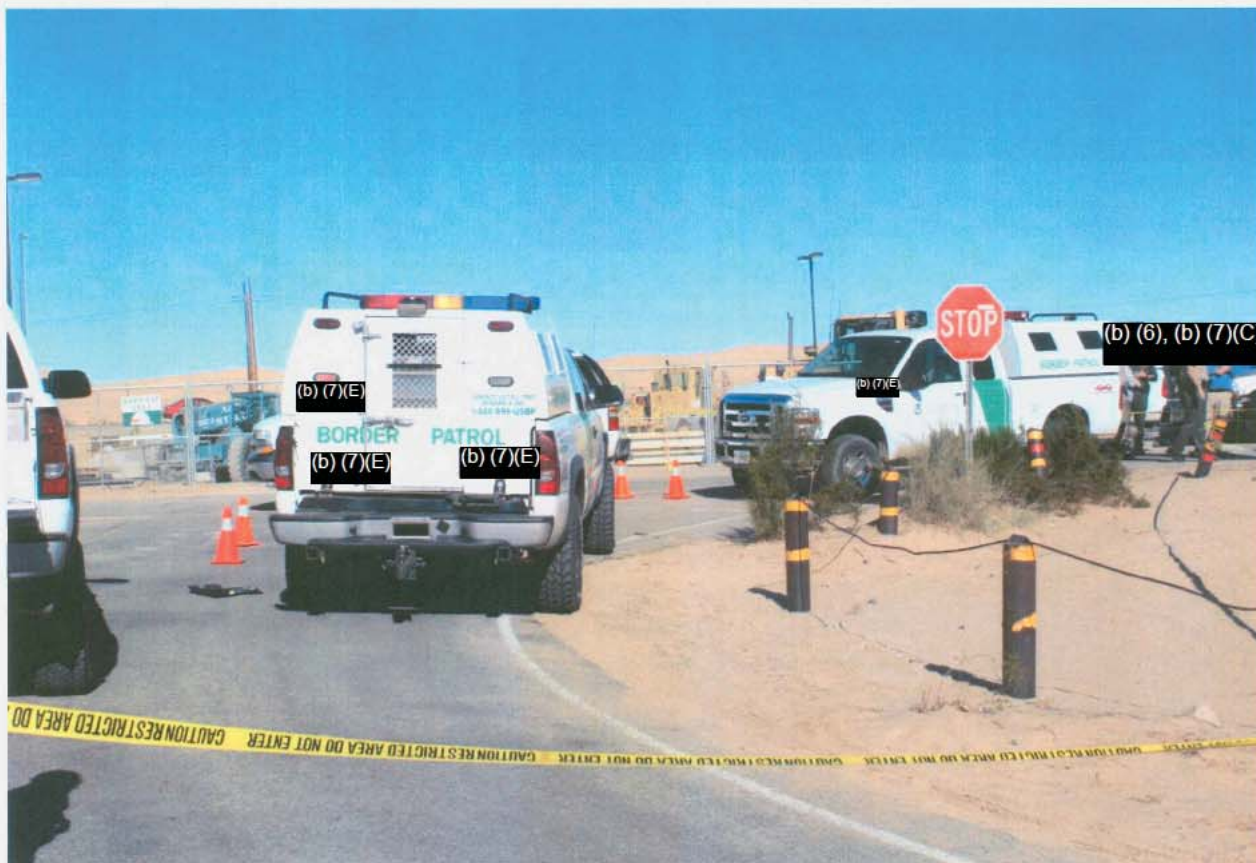
Digital Photograph 10 of 113

Description: Intersection of (b) (7)(E)  
(b) (7)(E) AGUILAR was standing near the pictured stop sign when struck.

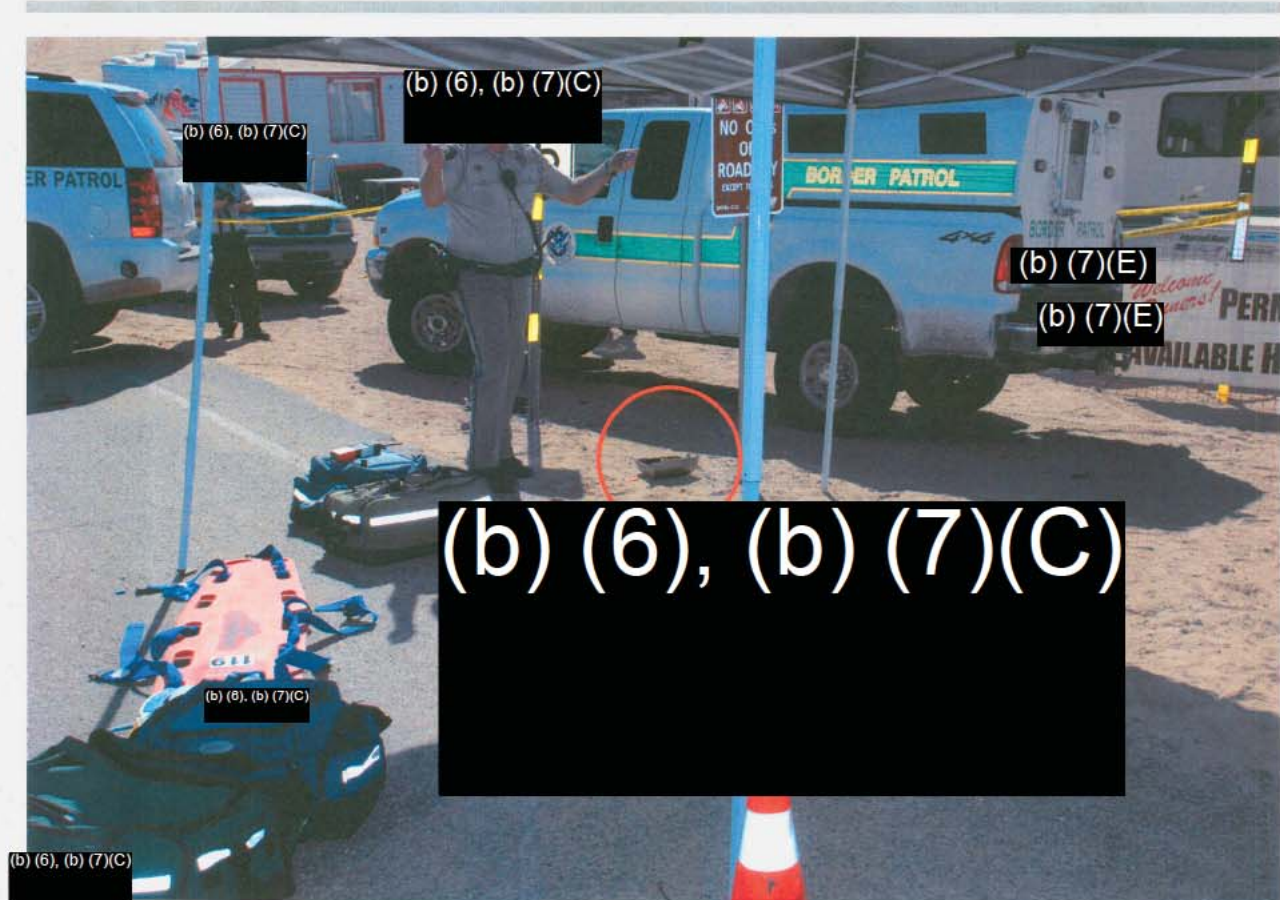
Digital Photograph 18 of 113

Description: (b) (6), (b) (7)(C) Air intake cover from suspect vehicle found in sand south of AGUILAR.

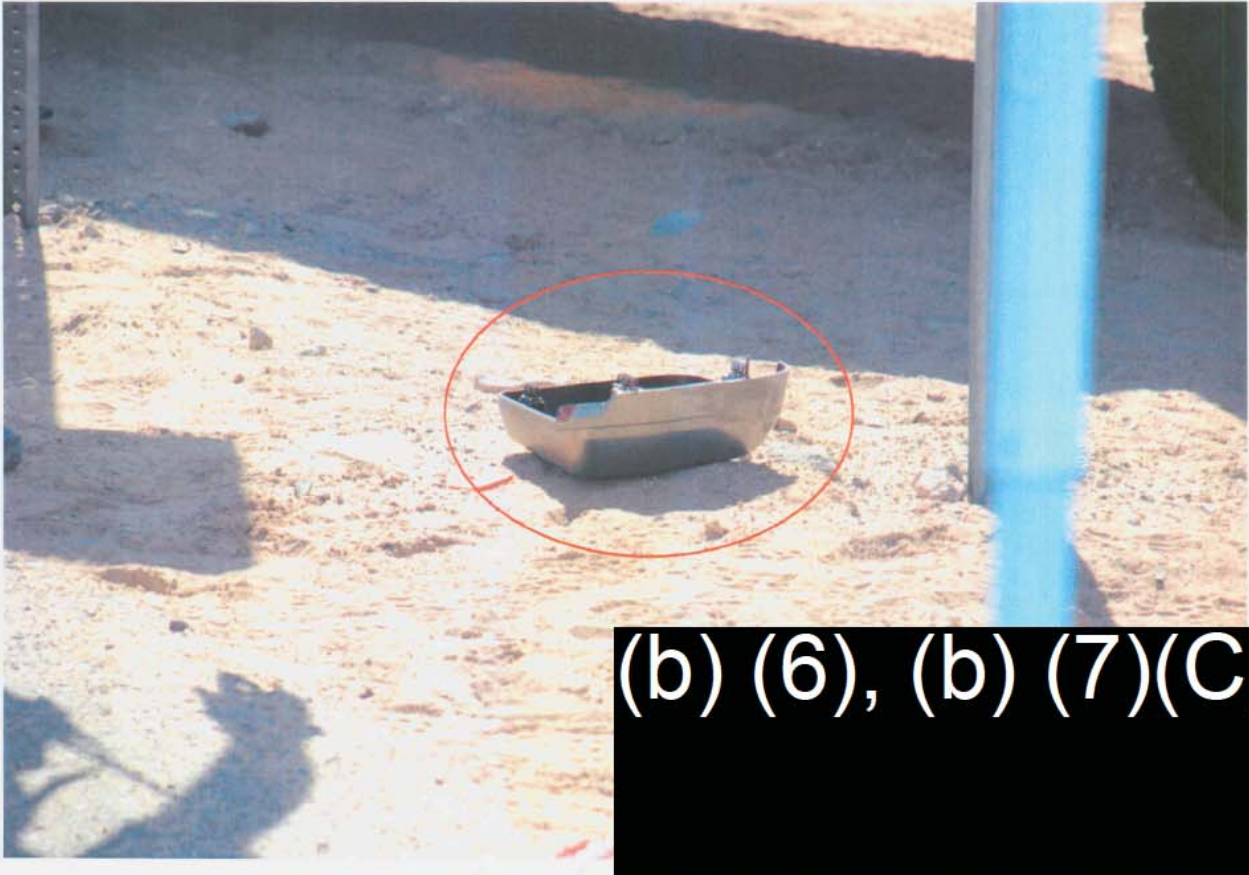
Digital Photograph 19 of 113

Description: Air intake cover found on scene from suspect vehicle (referenced in Photograph #22).

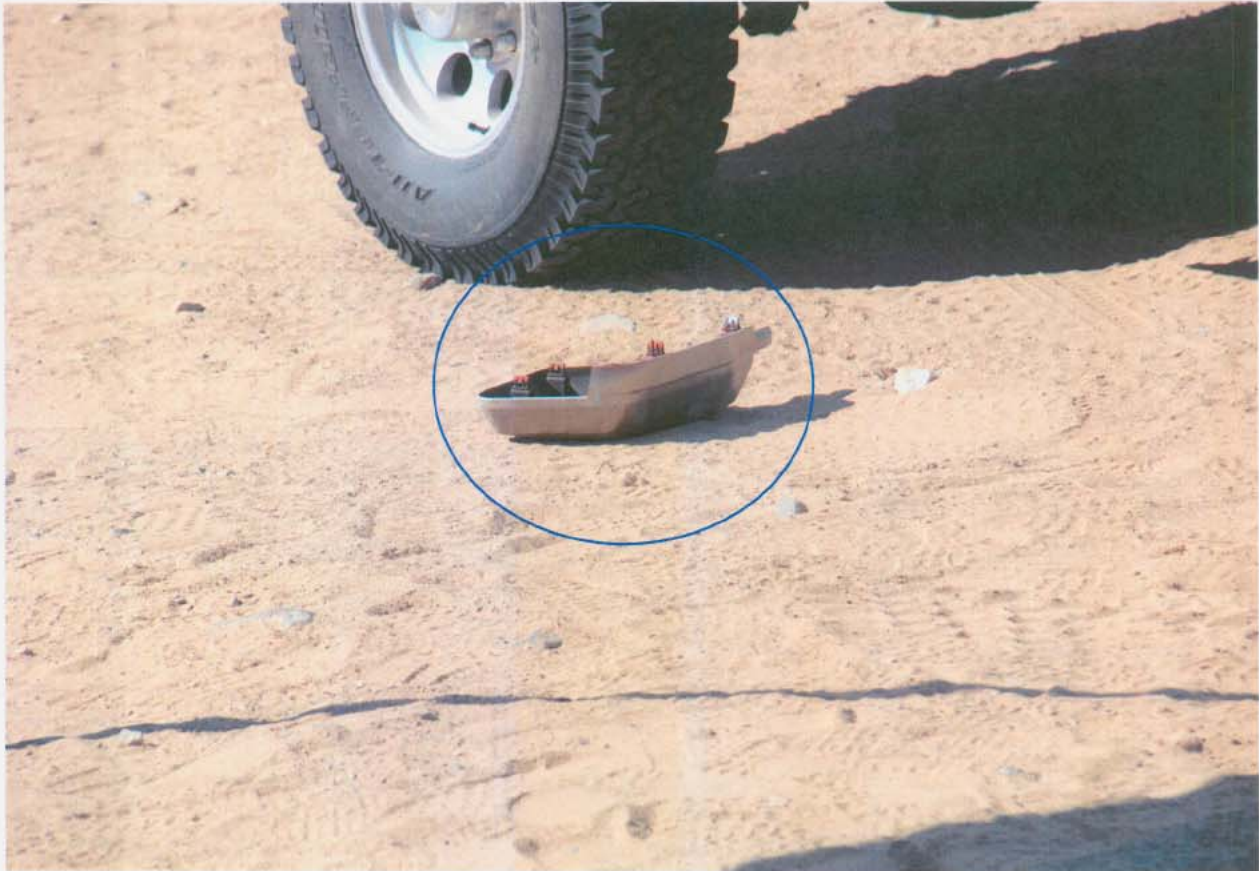
Digital Photograph 21 of 113

Description: Second air intake cover item found from suspect vehicle (referenced in Photograph #24).

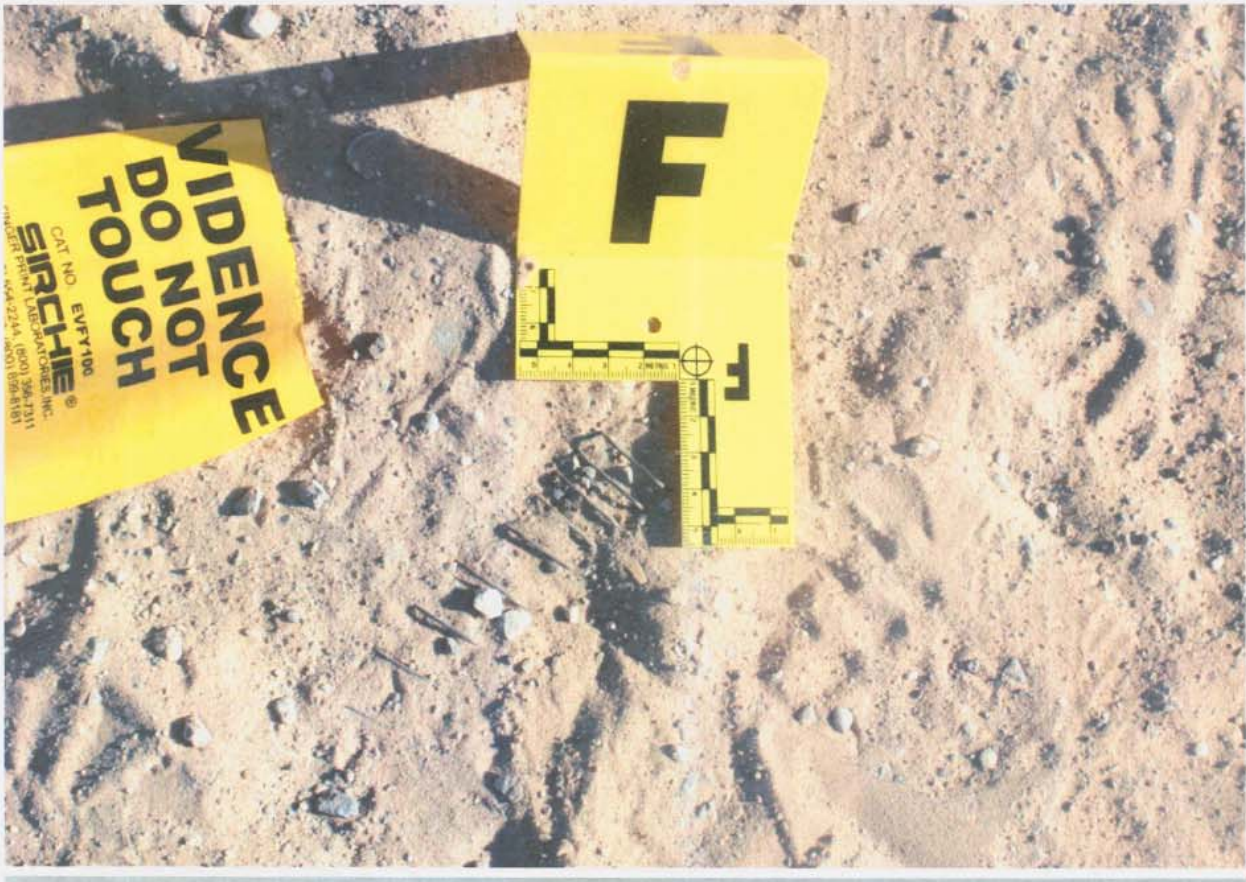
Digital Photograph 47 of 113

Description: Magazine spring belonging to AGUILAR that was located in sand approximately 6 feet from his final point of rest.

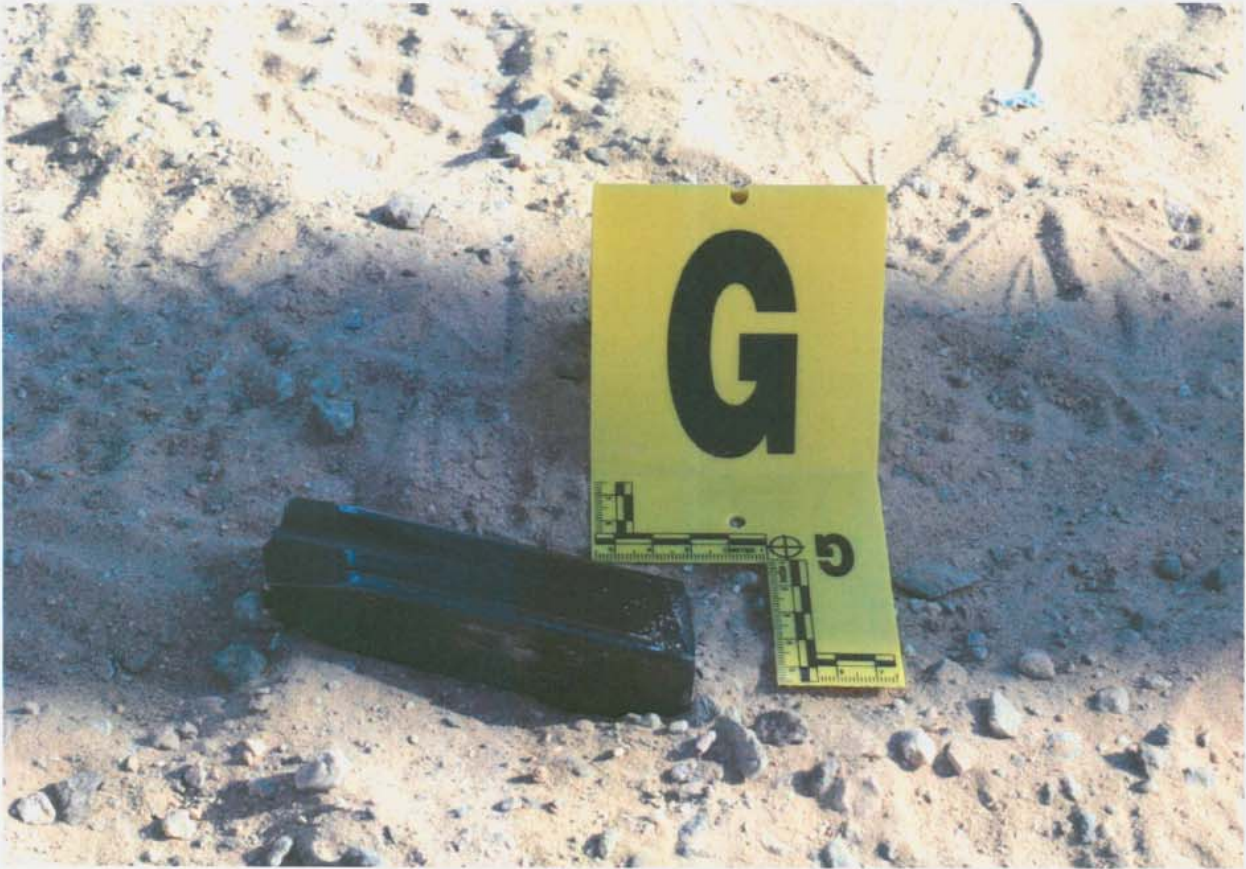
Digital Photograph 48 of 113

Description: Empty magazine belonging to AGUILAR that was located in sand approximately 16 ½ feet from his final point of rest.

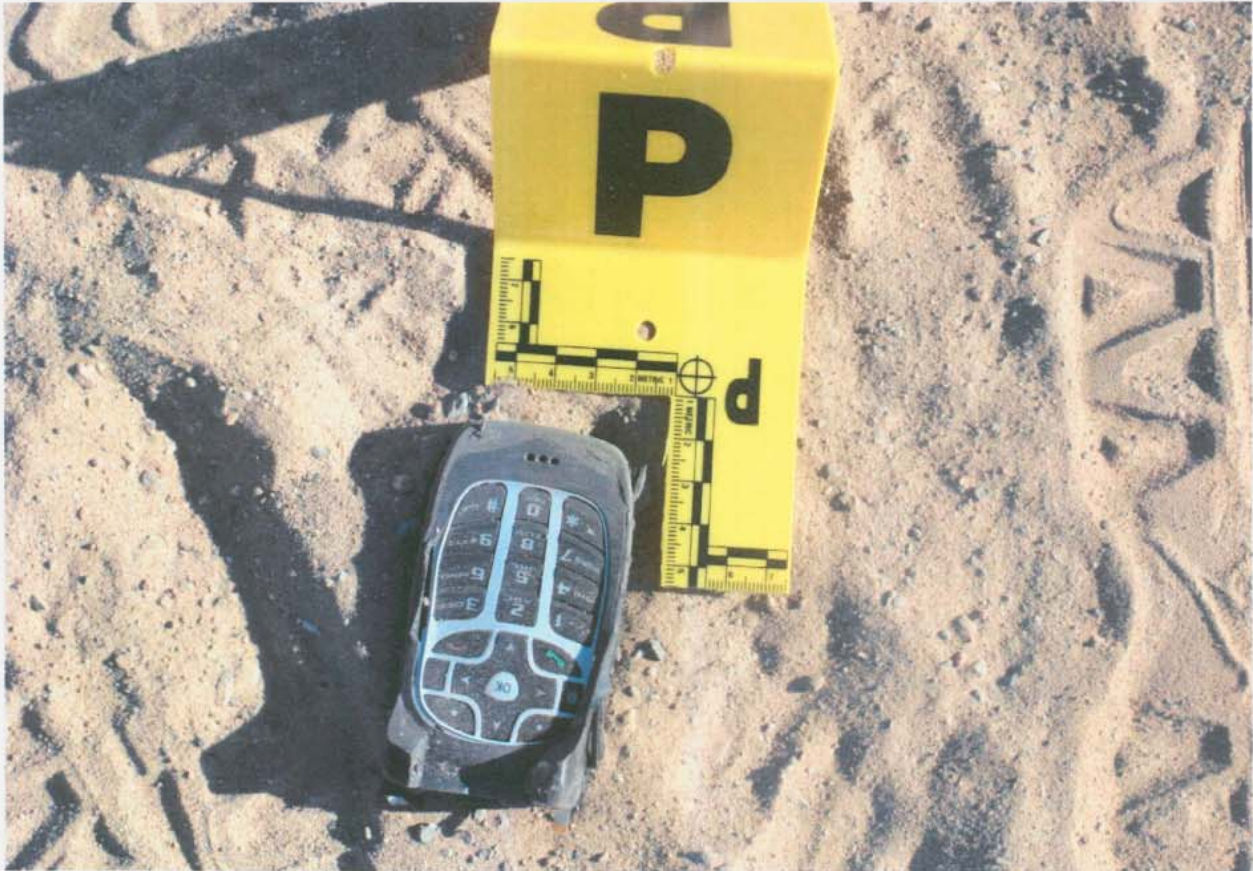
Digital Photograph 55 of 113

Description: Bottom portion of AGUILAR's government issued phone that was destroyed during incident.

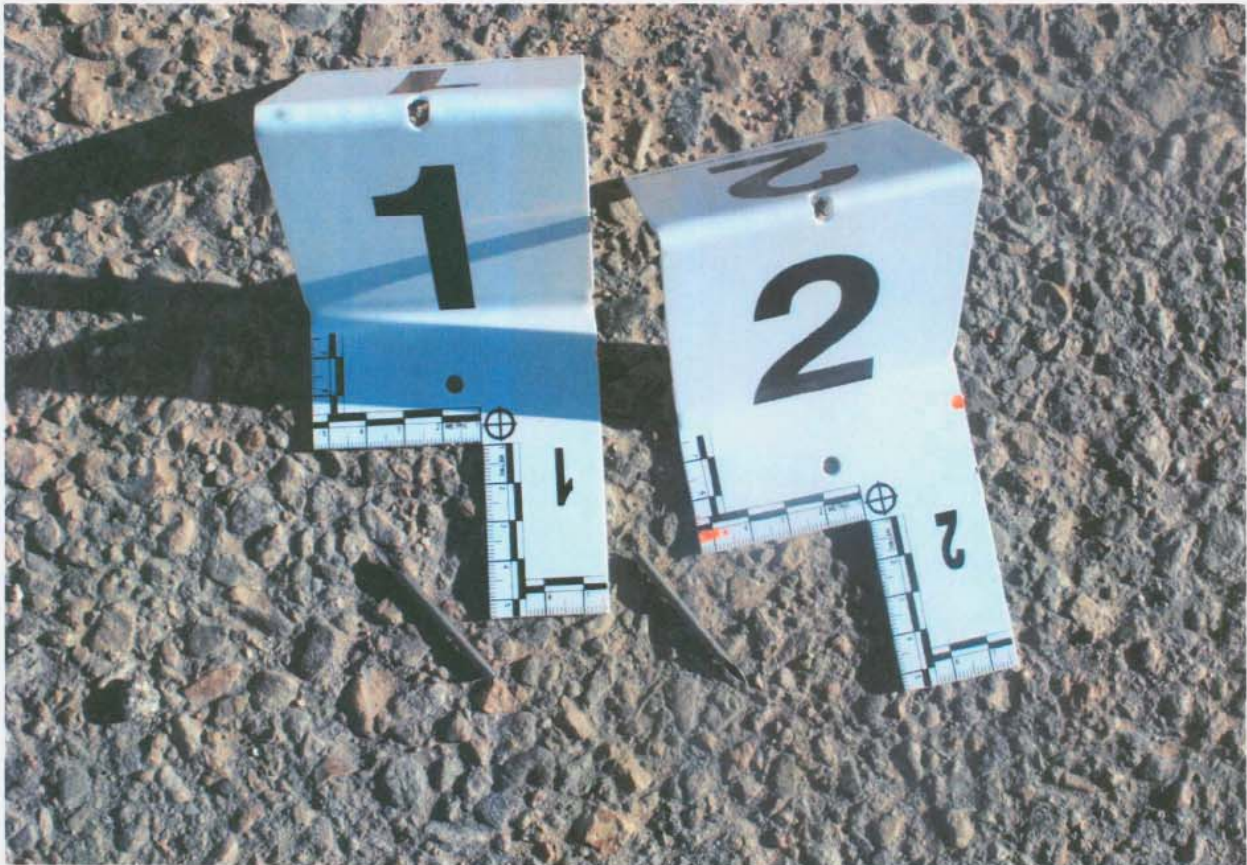
Digital Photograph 58 of 113

Description: Spikes that were ejected from the CTDD. Found approximately 60 feet east from AGUILAR's final point of rest.

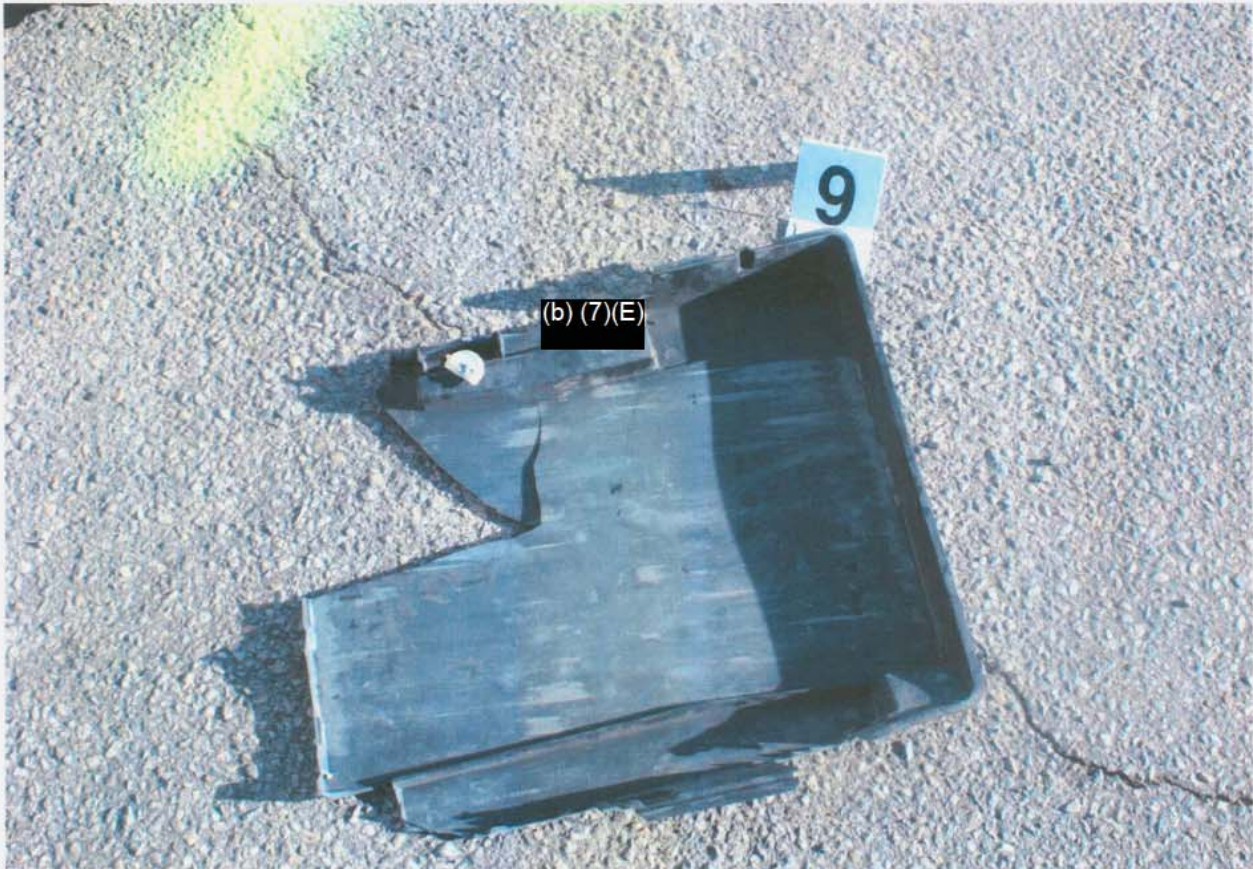
Digital Photograph 60 of 113

Description: Broken cover to CTDD case found approximately 18 feet east of AGUILAR's final point of rest.

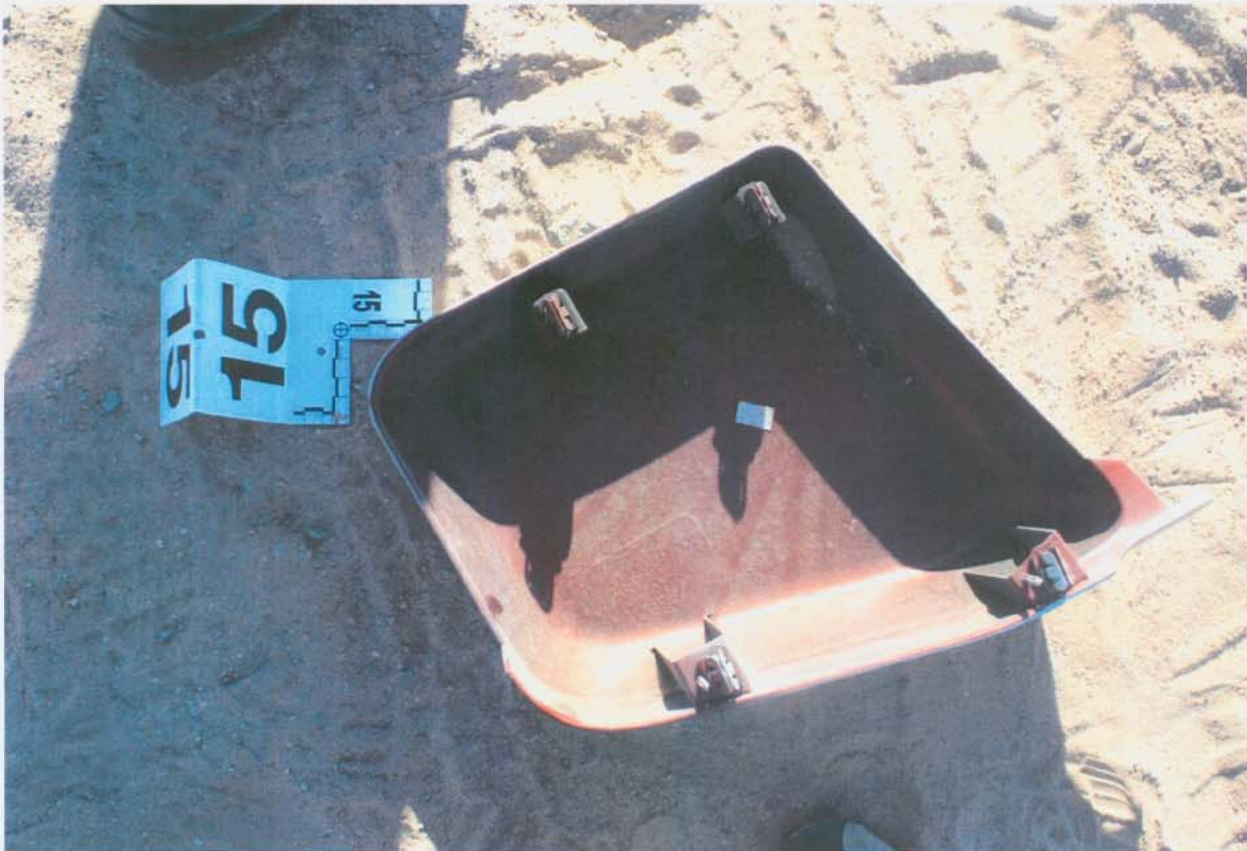
Digital Photograph 65 of 113

Two plastic air intake covers which were dislodged from the suspect vehicle were found near AGUILAR's body. The first cover was located approximately 12.5 feet northwest from AGUILAR, and the second cover was located approximately 10 feet south from AGUILAR. Both of the air intake covers were painted grey, which was consistent with witness descriptions of the suspect vehicle (See §6: pgs. 24-28 and 71-72). The air intake covers on the Hummer H2 are located on the driver and passenger side between the windshield and the hood (See §6: pgs. 114-116).

Description: Air intake cover that was dislodged from the Hummer during the incident.

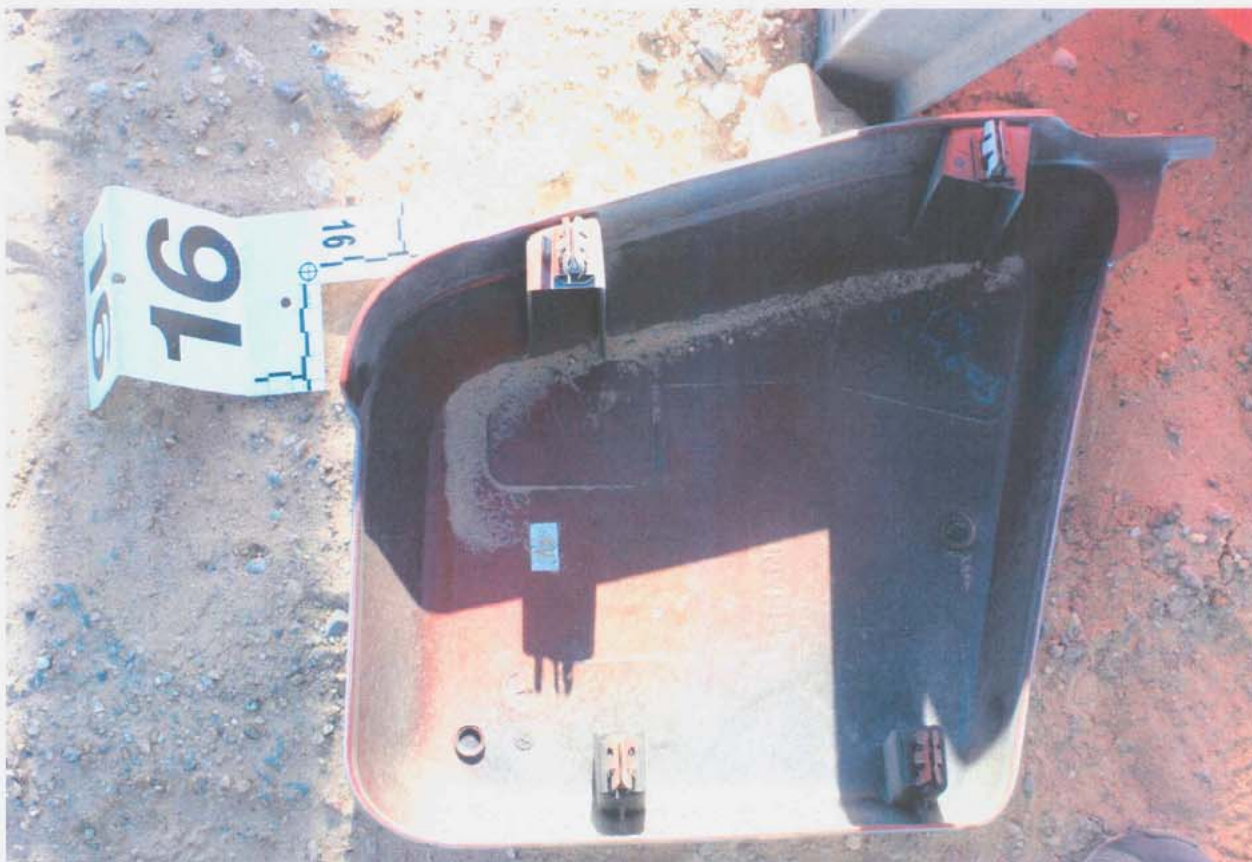
Digital Photograph 66 of 113

Description: Second air intake cover that was dislodge from the Hummer during incident.

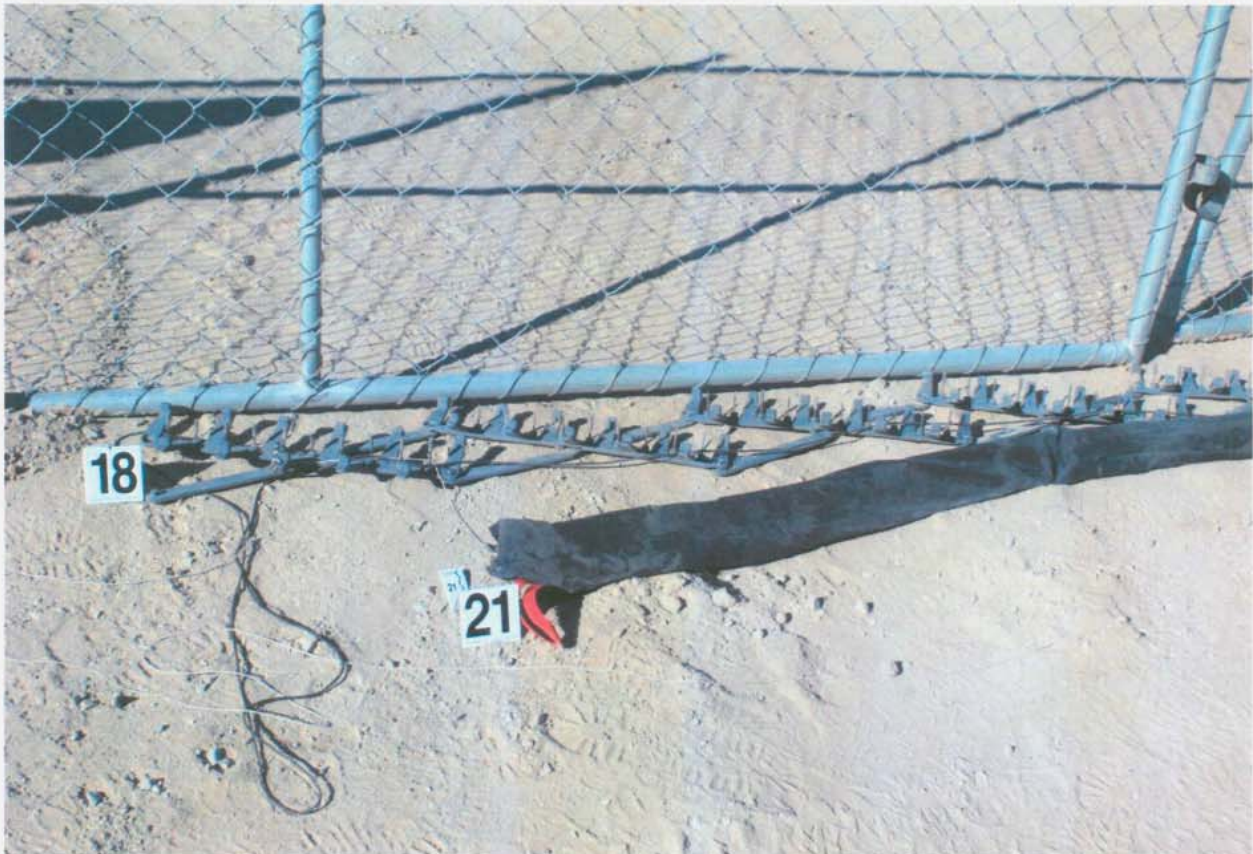
Digital Photograph 68 of 113

Description: Evidence marker 18 is the (b) (7)(E) CTDD that AGUILAR attempted to deploy. Evidence marker 21 is the (b) (7)(E) CTDD that was deployed by responding agents who feared that the truck would be returning through the area.

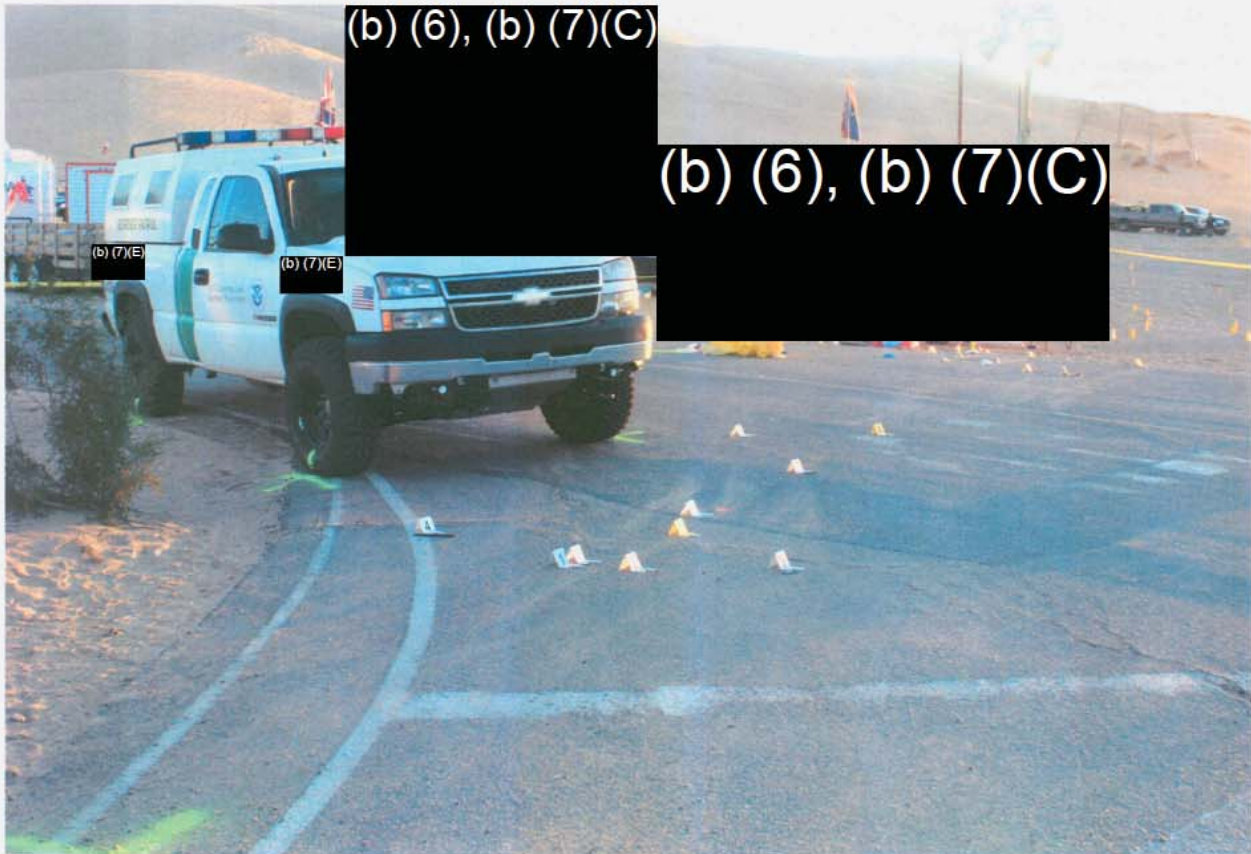
Digital Photograph 69 of 113

Approximately nine feet west of AGUILAR were a set of vehicle tire impressions. The tire impressions found traveled off-road from the southwestern edge of the (b) (7)(E) and they appeared to lead off toward the west. The tire impressions measured approximately six feet wide, with the longest impression defined measuring approximately 117 feet in length. The tire impressions continued to the west past the marked perimeter into the ISDRA. Due to the heavy traffic from the surrounding public, (b) (7)(E)

**Description:** View of incident scene from eastern intersection corner. Yellow flags leading off intersection to southwest indicate the Hummer's tire impressions.

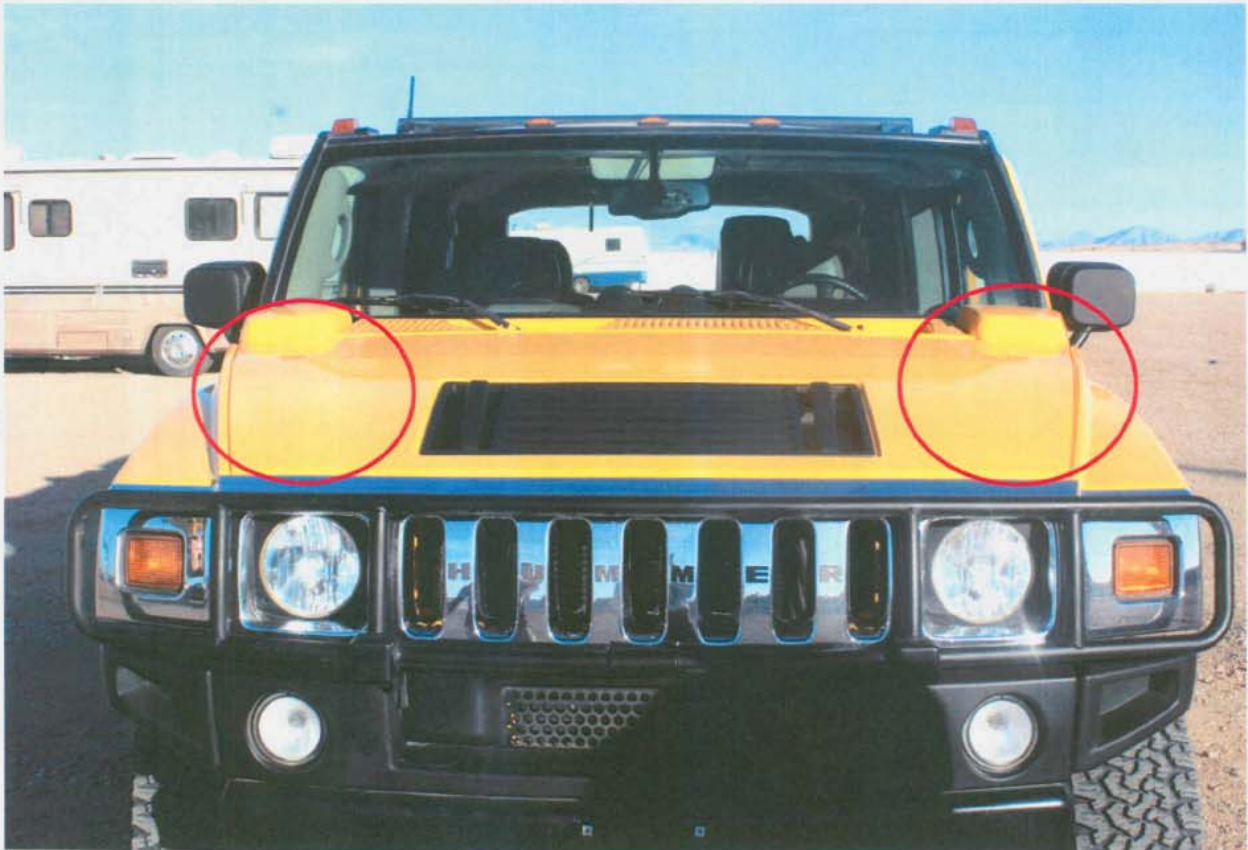
Digital Photograph 108 of 113

Description: Front end of 2003 H2 Hummer. Air intake covers circled in red are similar to covers found on scene as evidence.
